Drinking water tanks –  
coatings of

**Enjoy drinking water –  
with *epasit***

For more than 30 years internal coatings in drinking water tanks

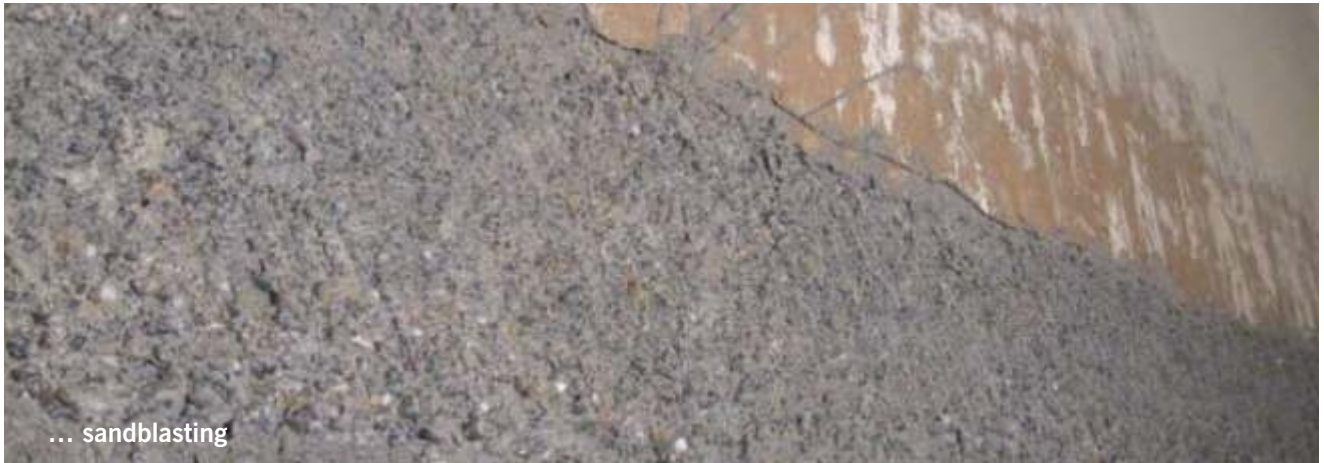
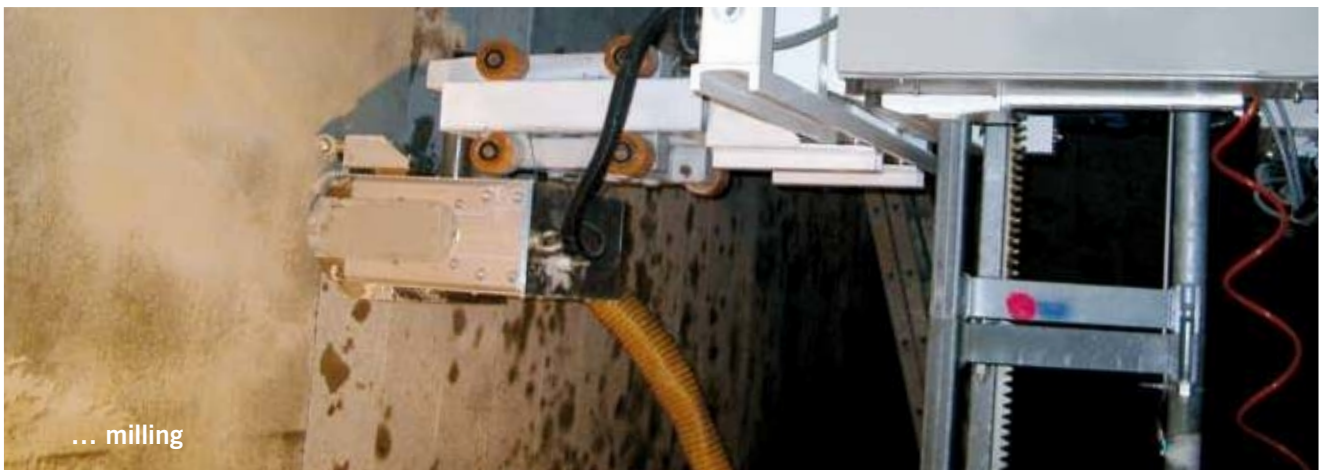
Removing the old films by...

A stable substrate is a prerequisite for the permanent adhesion between substrate and coating system. Therefore, the substrate has to be examined and prepared before applying the coating.

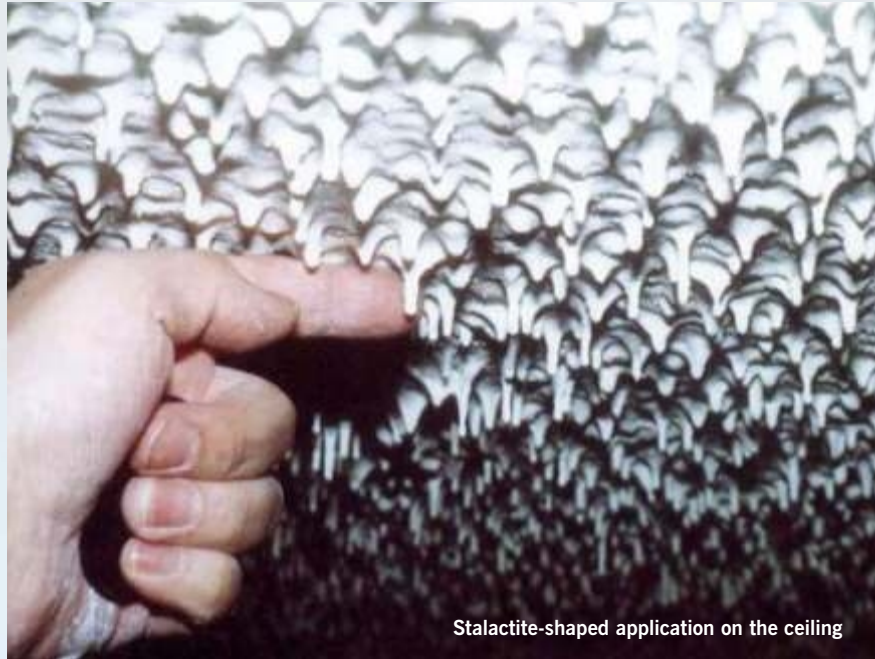
Stalactite-shaped application on the ceiling

the surface to be coated by using a trowel. By treating the surface with a smoothing trowel a level surface will be obtained. When applying the mortar mechanically, the coating may be applied in one working cycle on the ceiling with the help of an appropriate machine. Vertical areas are sprayed on in one or

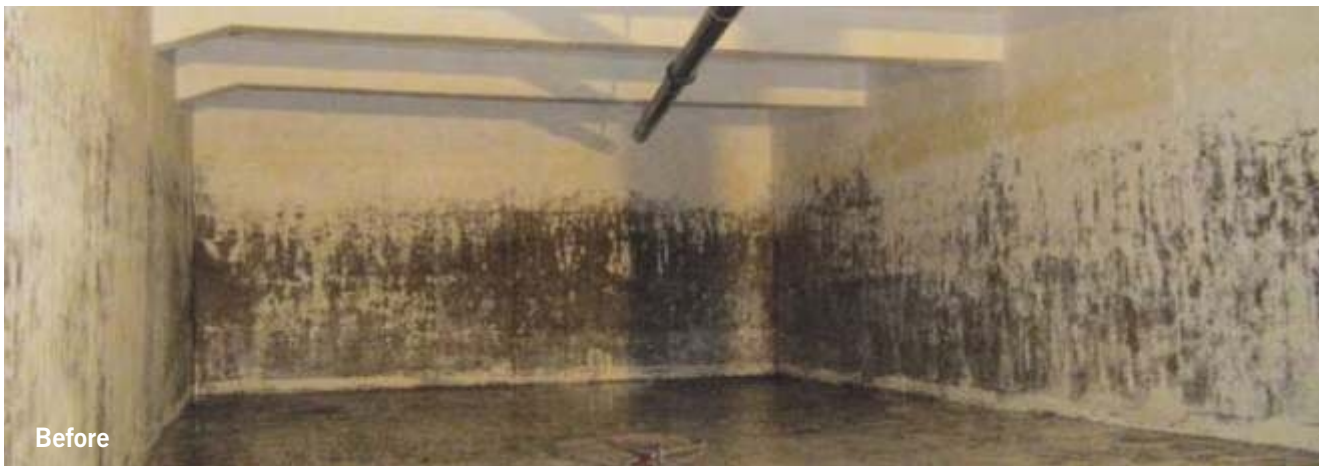
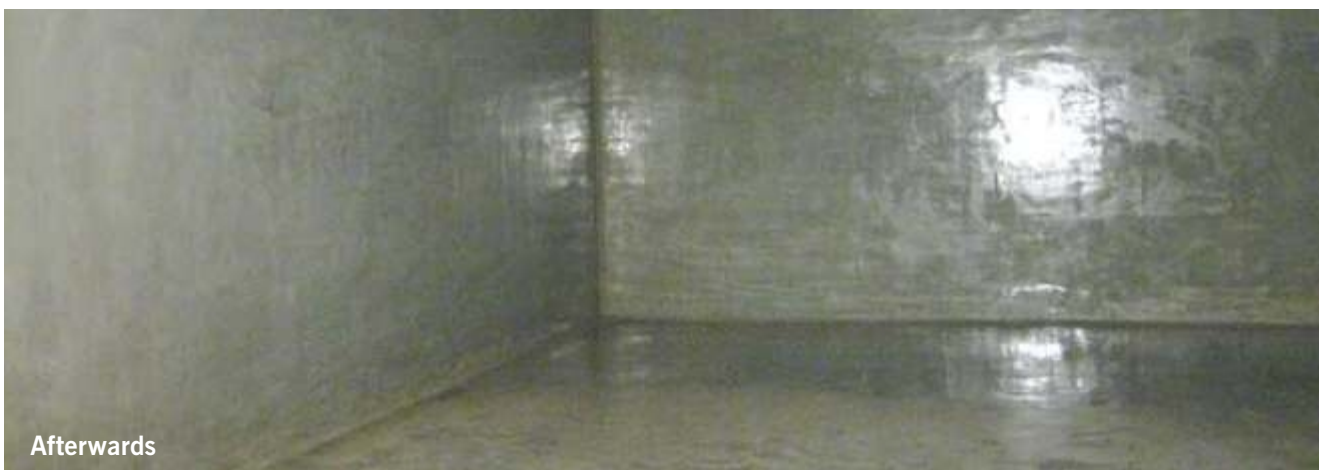
## Coated and not coated drinking water tanks

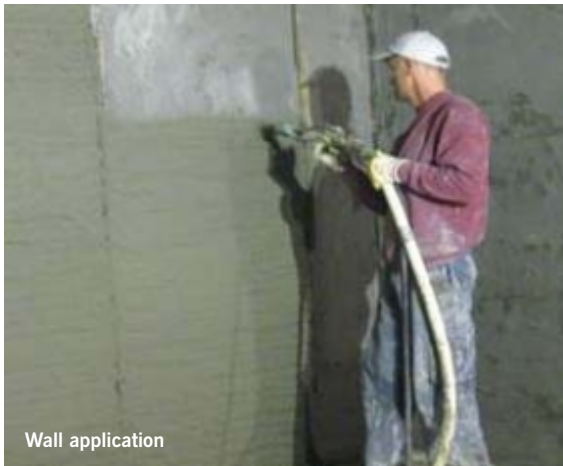
Wall application

two layers up to the required film thickness and are smoothed over with a smoothing trowel. The surface structure of the coating depends on the processing technology.

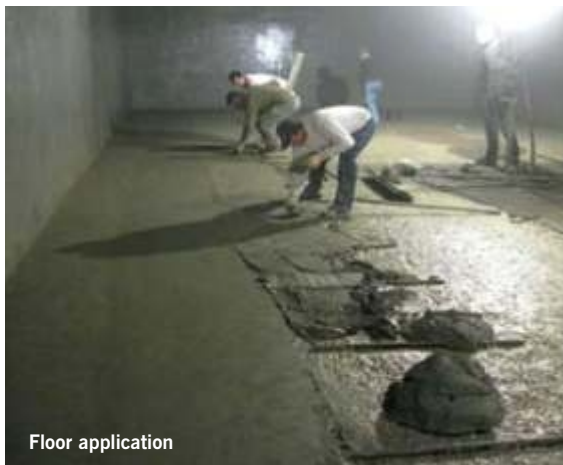
Floor application

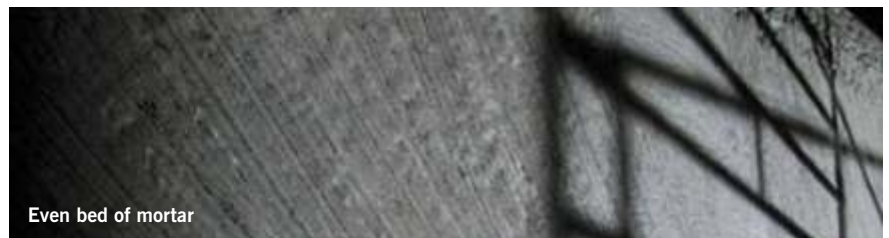
Even bed of mortar
